**City of Los Angeles
WATERSHED PROTECTION DIVISION
ENVIRONMENTAL ENFORCEMENT & EMERGENCY RESPONSE UNIT**

CASE #52967

Spill/Fire Investigation

Case #52967 – 210 W Slauson Ave – fuel spill and tanker fire
Prepared by Environmental Compliance Officer Cook

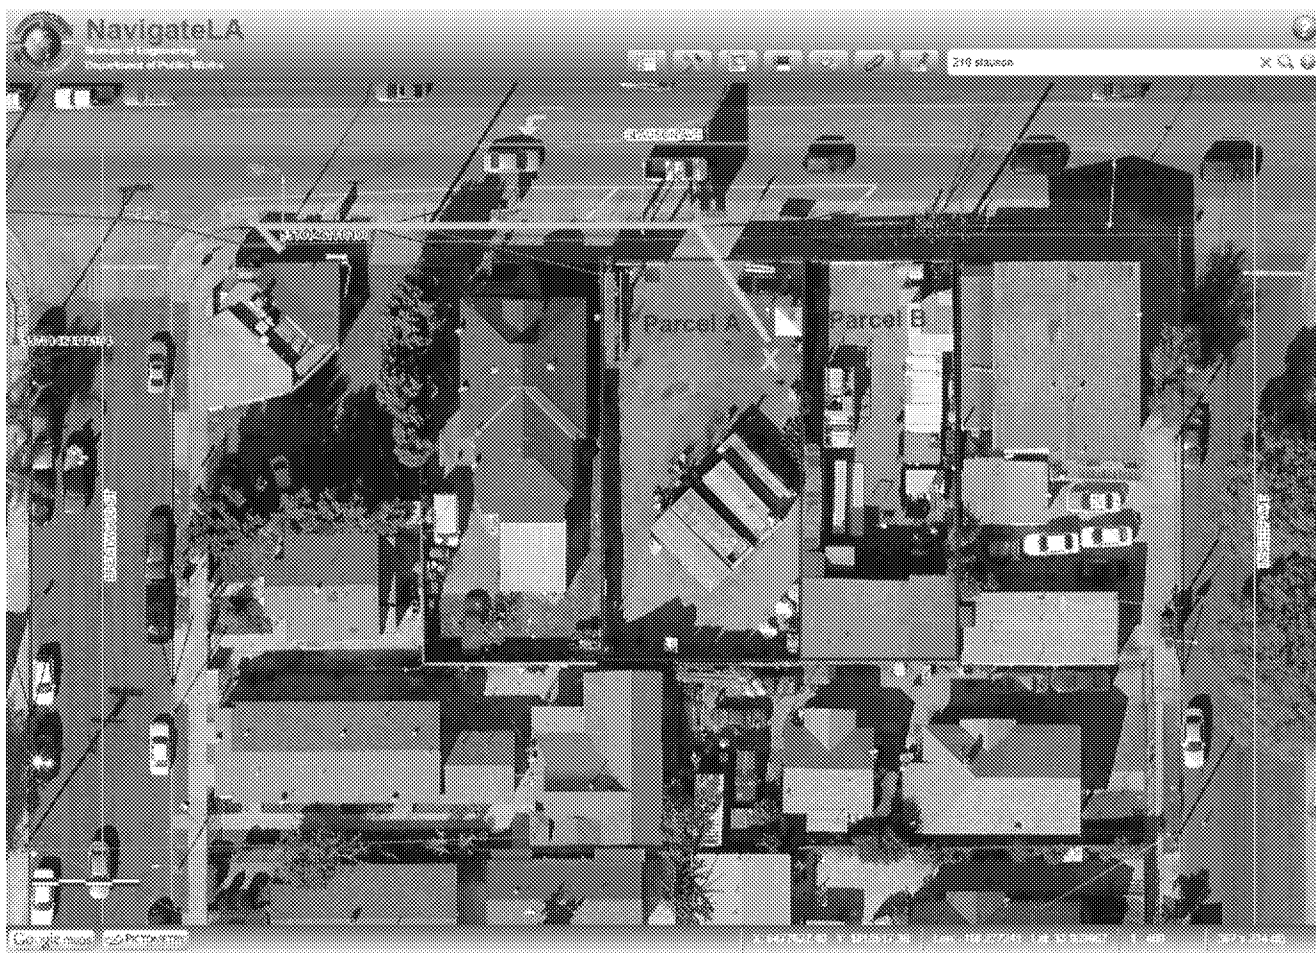
Figure #1.

Bird's eye/overhead view NavigateLA satellite map of incident at 210 W Slauson Ave, outlined and labeled in red. The incident occurred on "Parcel A" of the property, with the spill/fire beginning at the blue "X" and entering the storm drain catch basin (#5570146111100).

At approximately 1045 hrs, ECI Tran and I arrived at 210 W Slauson Ave. The temperature was about 79 degrees Fahrenheit and the sky was clear and sunny. The following entities were on site upon our arrival: Los Angeles County Health Hazmat, LAFD, LAPD, Los Angeles City Department of Transportation (DOT), Public Works Storm Maintenance and WCSD. The designated "command center" for the incident was a Mobil gas station located at 254 West Slauson Ave. I received a brief summary from LAFD, who stated a fuel/water mixture leaked from a 9,000 gallon tanker that was on the property of 210 W Slauson Ave, was released along the curb of Slauson Ave, discharged into the storm drain, caught fire, and the resulting explosion "blew off" several manhole covers along Slauson Ave. Per NavigateLA, the affected catch basin's number was #55701461111100 (along south Slauson Ave sidewalk; at the southeast corner of Slauson Ave and Broadway [Figure 1]).

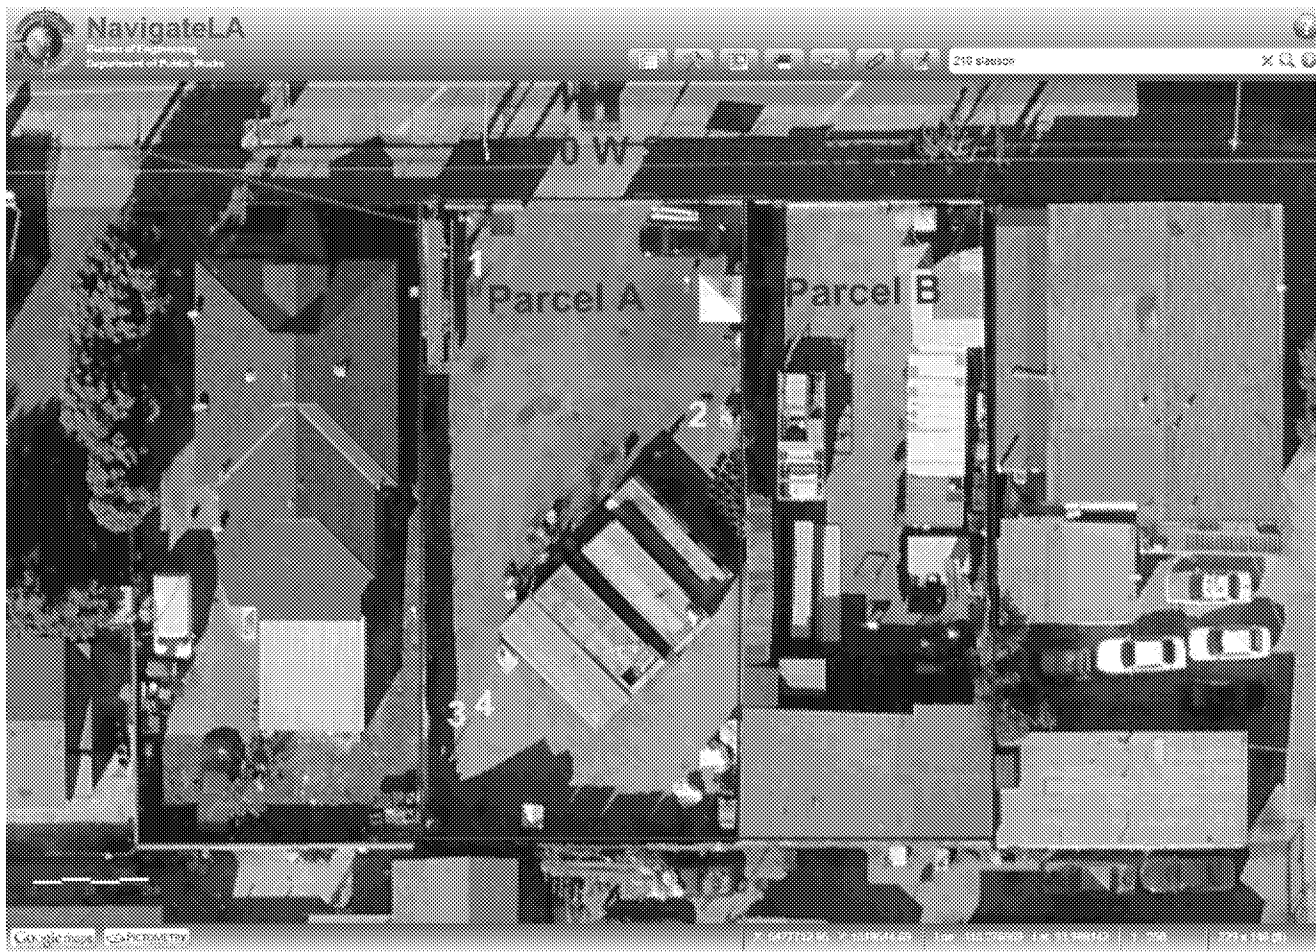
Figure #2.

Zoomed-in overhead view NavigateLA satellite map of incident at 210 W Slauson Ave, outlined and labeled in red. The incident occurred on “Parcel A” of the property, with relevant spots marked in yellow numbers:

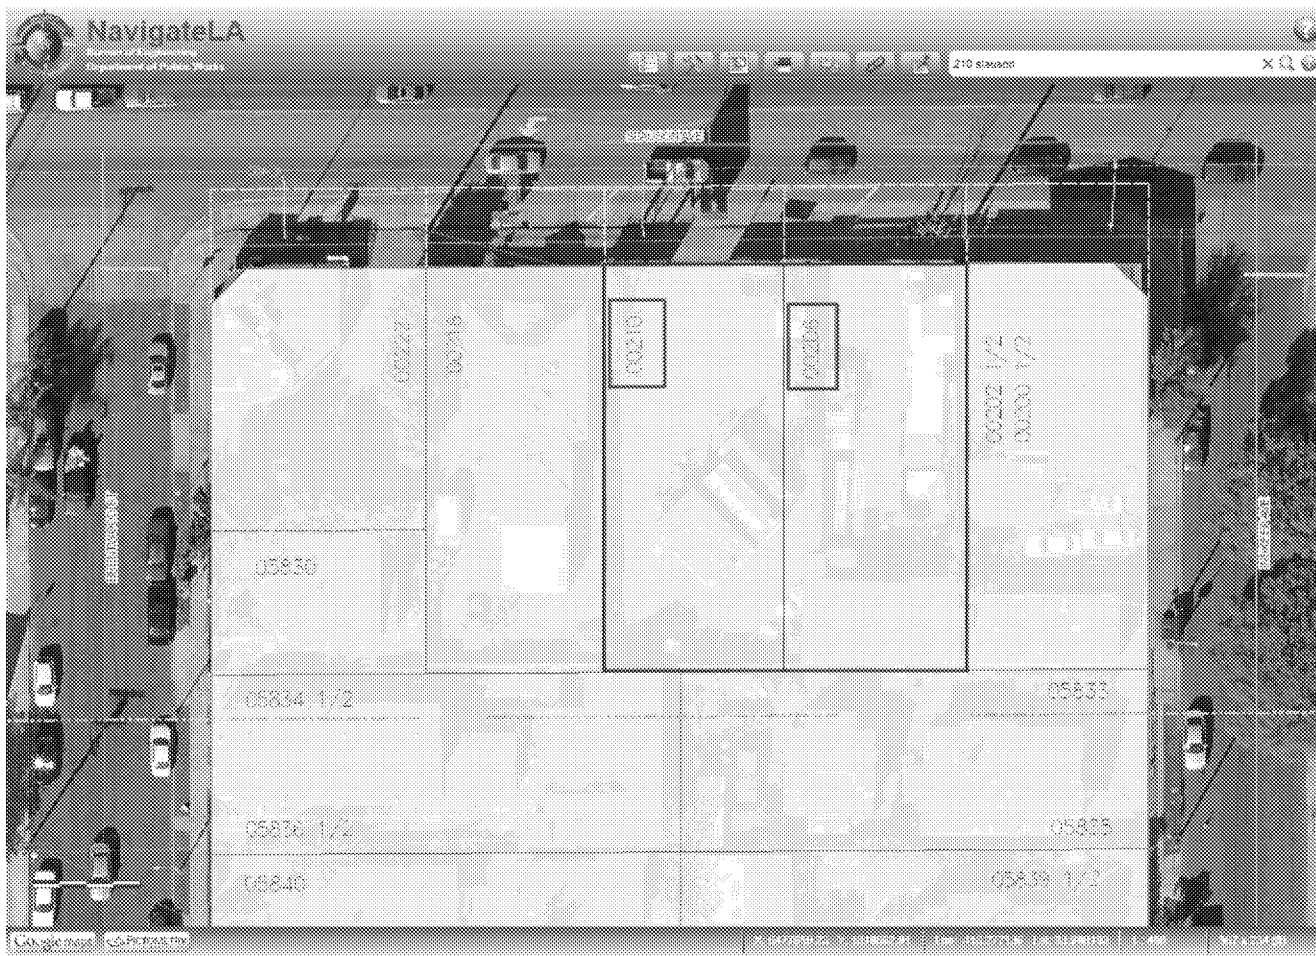
Figure #3.

- 1 = Area where fire-damaged vehicle and billboard were found
- 2 = Area where above-ground storage tank/“tanker” was found; fuel spill began here
- 3 = Area where one of two fire-damaged trailers were found
- 4 = Area where the second fire-damaged trailer was found
- 5 = Area where trailer belonging to Mr. Byung Chun Chuong was found

Overhead view NavigateLA satellite map of property where incident originated, outlined in red. This map indicates that “Parcel A’s” address is 210 W Slauson Ave, and “Parcel B’s” address is 206 W Slauson Ave.

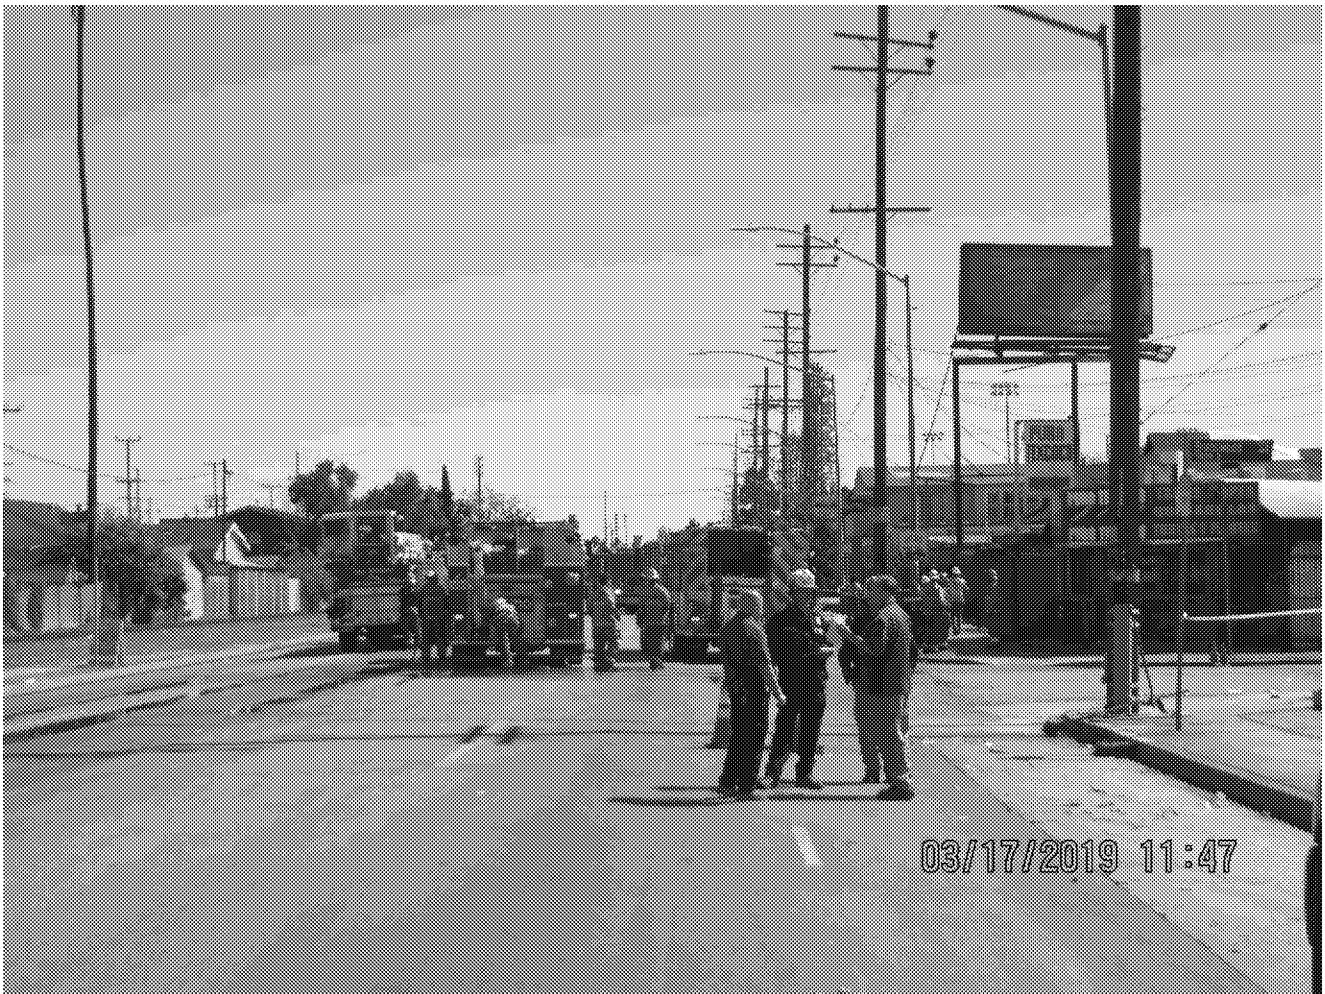
Figure #7.

View facing east on Slauson Ave; scene of incident upon WPD's arrival. Incident location (210 W Slauson Ave) east of pictured red taco building, under the billboard.

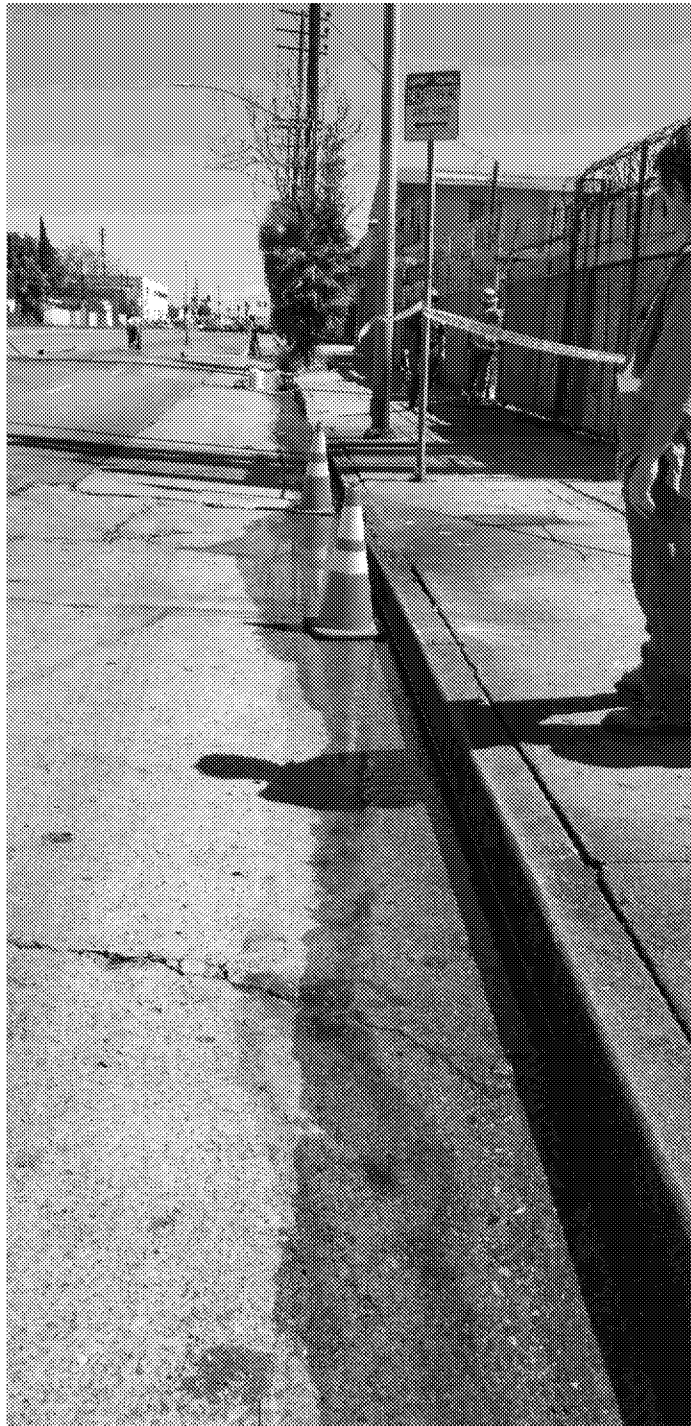
Figure #8.

View facing east on Slauson Ave; scene of incident upon WPD's arrival. Fuel & water mixture along public curb. Incident location (210 W Slauson Ave) is behind pictured LAFD firefighter.

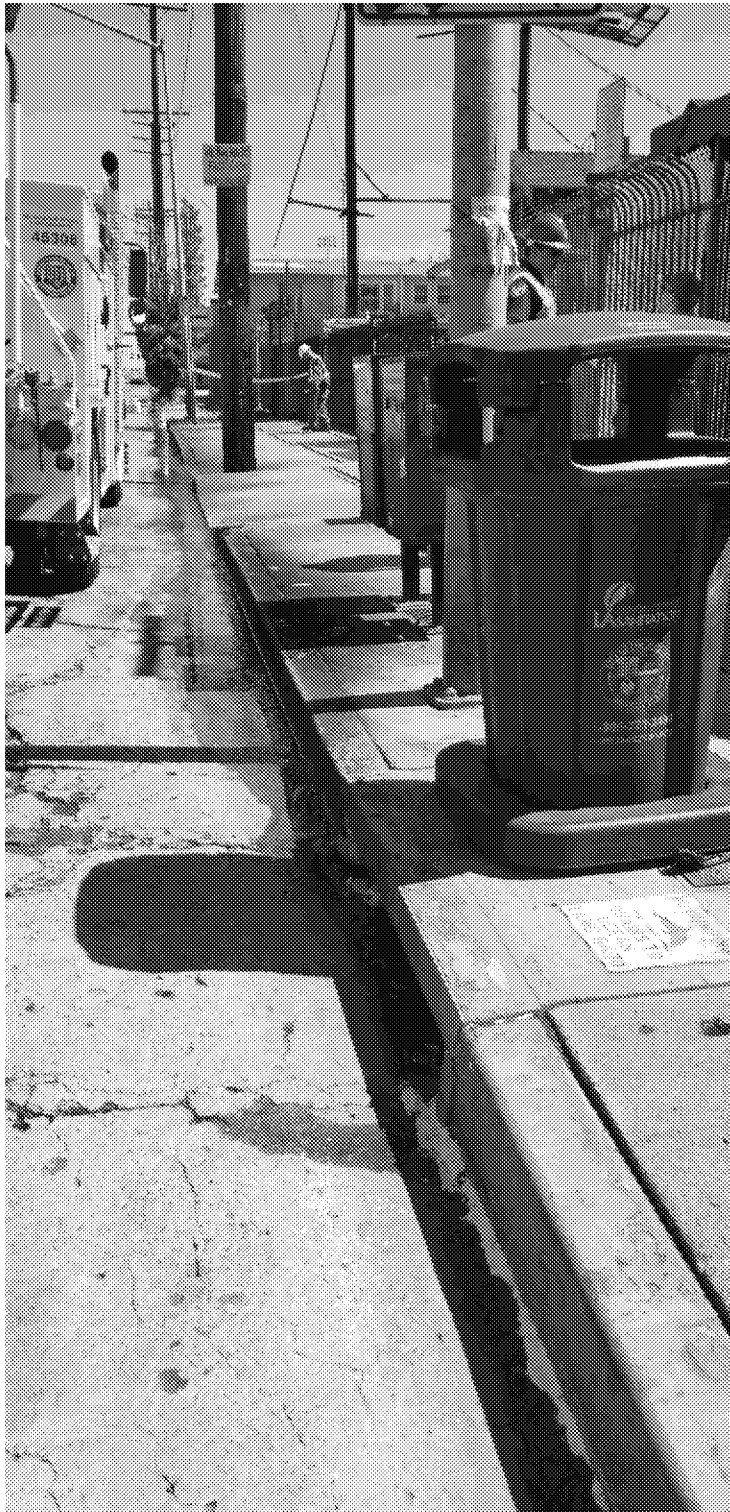
Figure #9.

View facing east on Slauson Ave; scene of incident upon WPD's arrival. Fuel & water mixture along public curb discharging into storm drain catch basin ##55701461111100. Incident location (210 W Slauson Ave) is adjacent to pictured yellow caution tape.

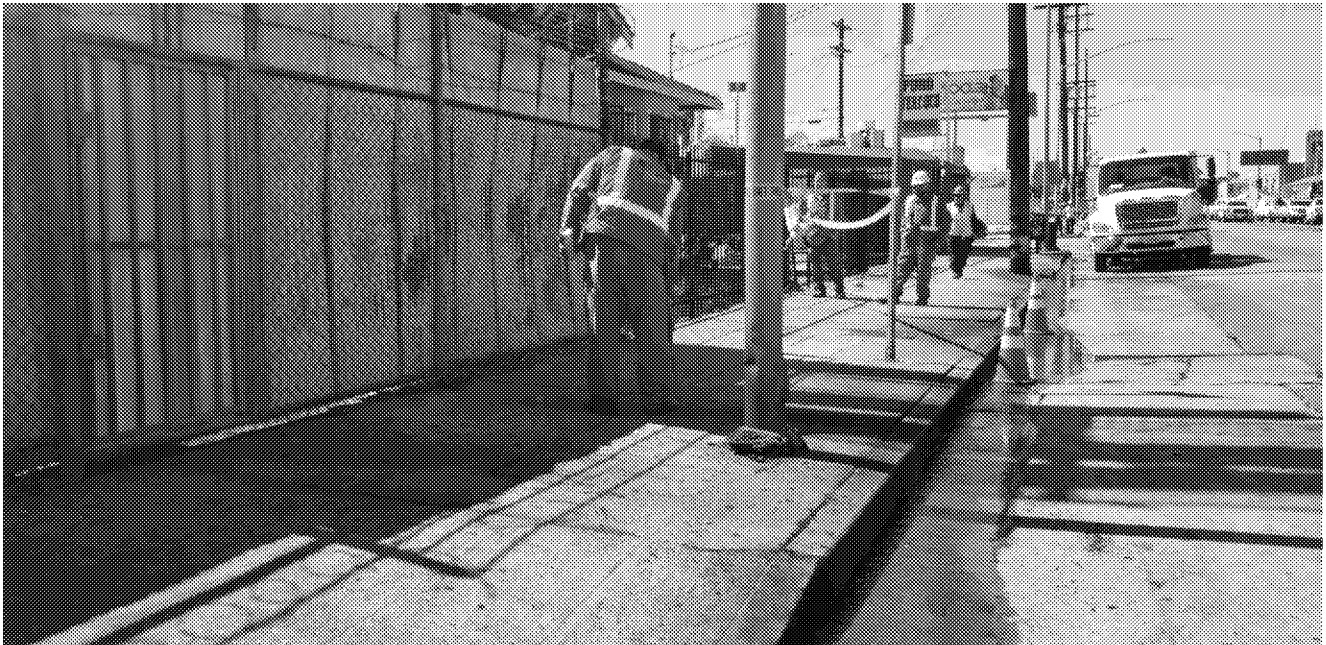
Figure #10.

View facing west on Slauson Ave. Fuel & water mixture along public curb. Incident location (210 W Slauson Ave) is behind pictured metal fencing.

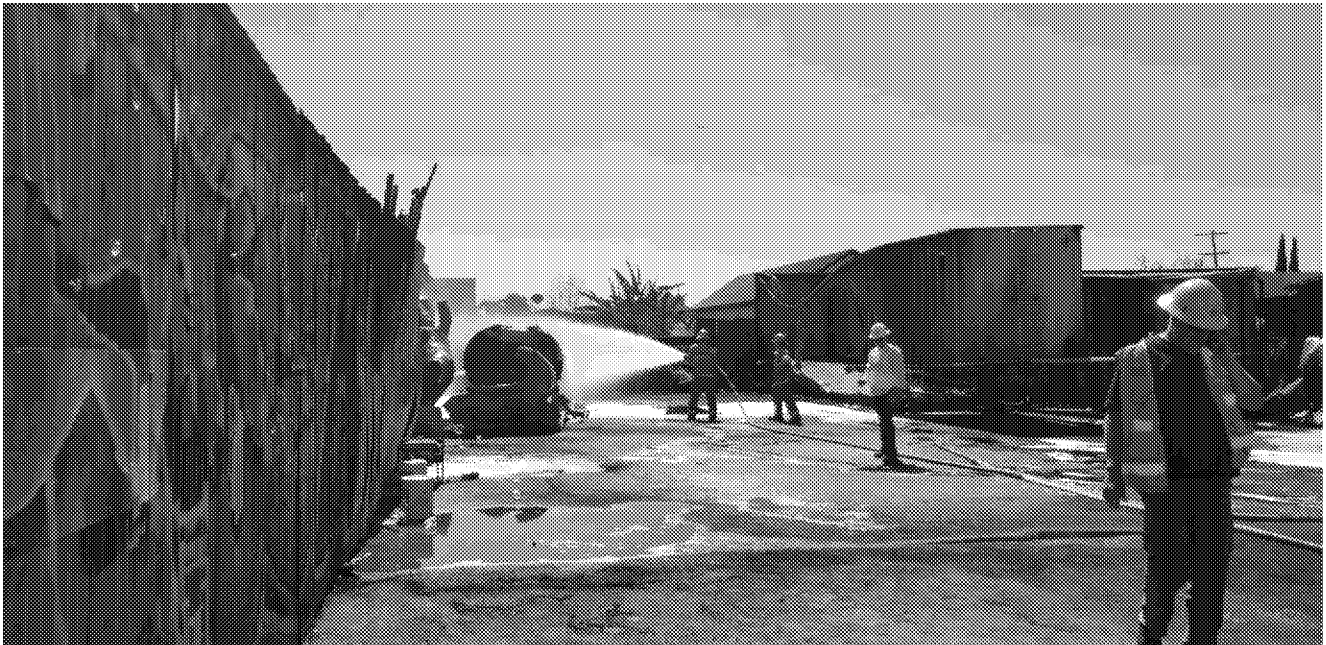
Figure #11.

View facing south at incident location 210 W Slauson Ave, Parcel A, with LAFD firefighter hosing down fire-damaged “tanker” full of fuel. Ground pooling is likely a mixture of fuel, water and fire retardant. Also pictured: fire-damaged fencing and fire-damaged trailer.

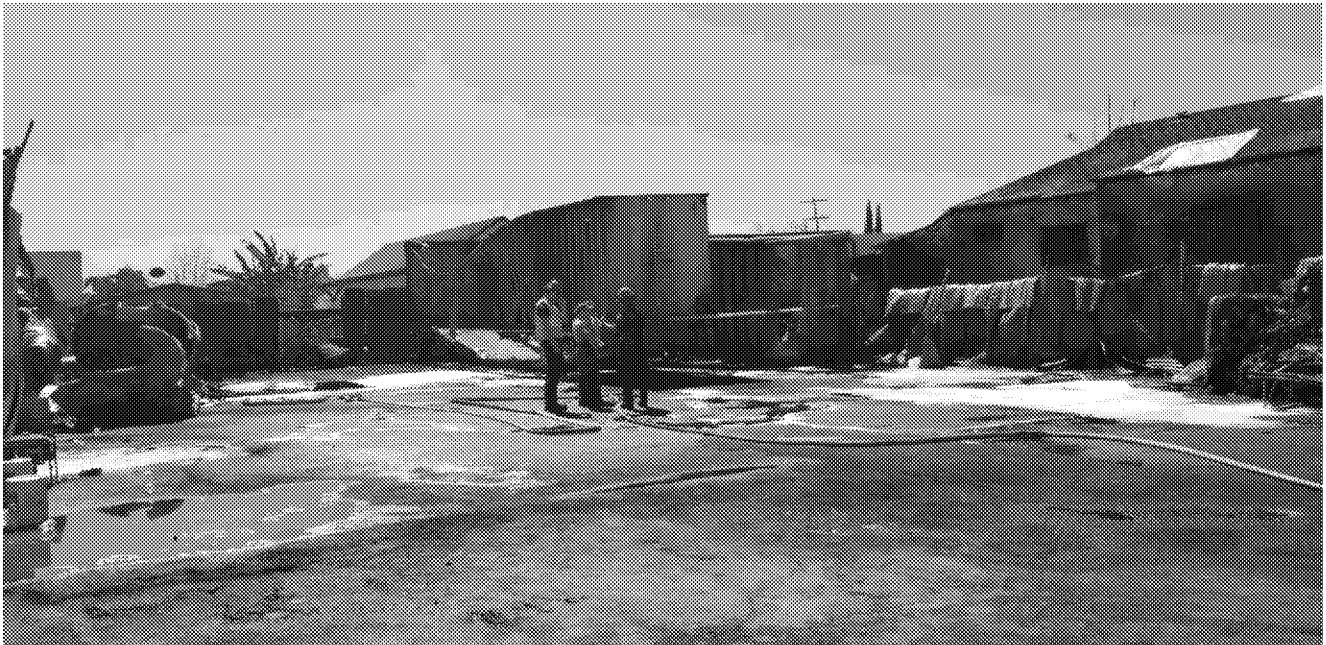
Figure #12.

View facing southwest at 210 W Slauson Ave, Parcel A, with fire-damaged “tanker,” two fire-damaged trailers, fire-damaged fencing, and fire-damaged home 216 W Slauson Ave. Ground pooling is likely a mixture of fuel, water and fire retardant.

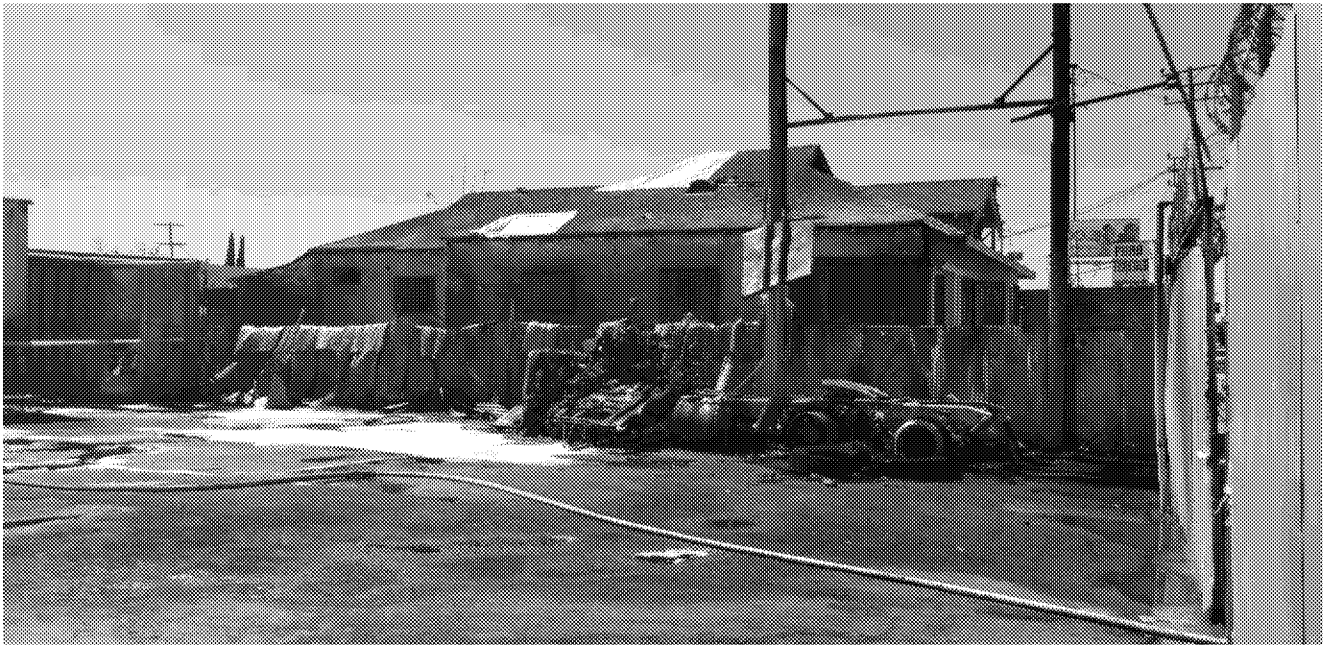
Figure #13.

View facing west at 210 W Slauson Ave, Parcel A, with fire-damaged fencing, fire-damaged vehicle, fire-damaged billboard supports, and fire-damaged home 216 W Slauson Ave. Ground pooling is likely a mixture of fuel, water and fire retardant.

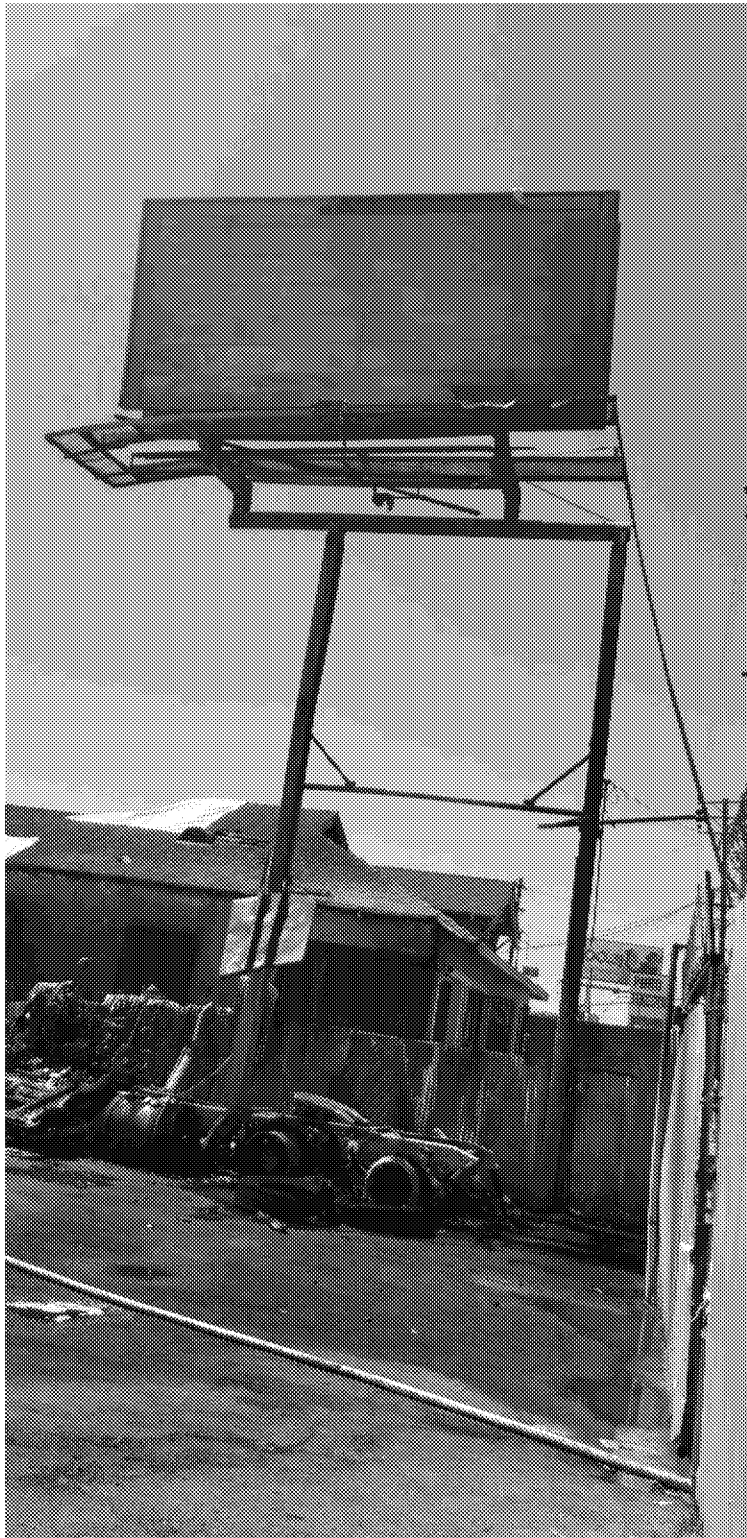
Figure #14.

View facing west at 210 W Slauson Ave, Parcel A, with fire-damaged fencing, fire-damaged vehicle, fire-damaged billboard, and fire-damaged home 216 W Slauson Ave. Ground pooling is likely a mixture of fuel, water and fire retardant.

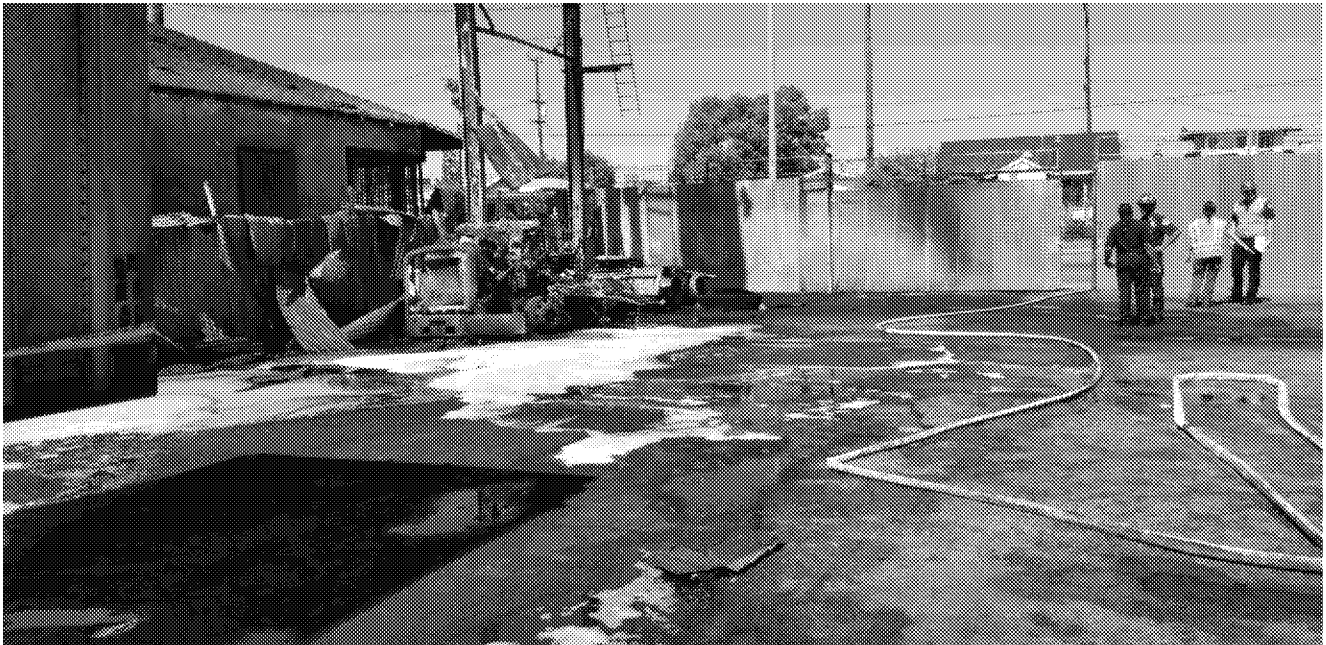
Figure #15.

View facing northwest at 210 W Slauson Ave, Parcel A, with fire-damaged fencing, fire-damaged vehicle, fire-damaged billboard supports, and fire-damaged home 216 W Slauson Ave. Ground pooling is likely a mixture of fuel, water and fire retardant.

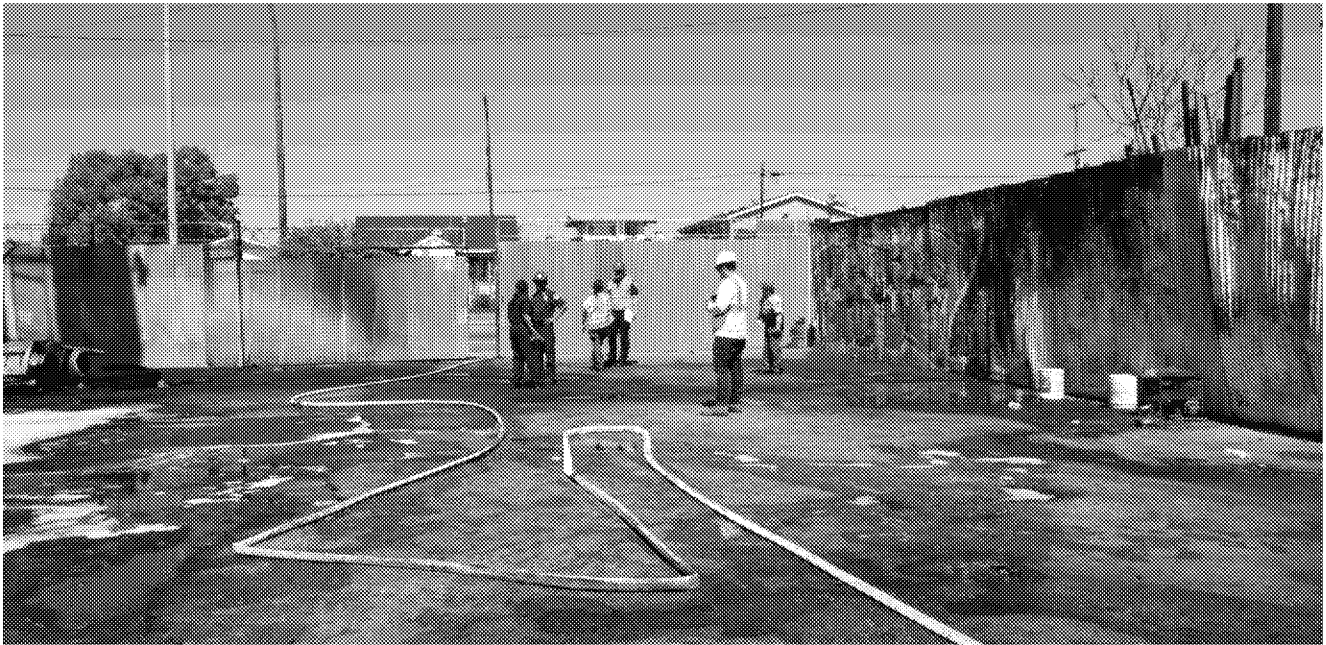
Figure #16.

View facing north at 210 W Slauson Ave, Parcel A, with fire-damaged fencing pictured. Ground pooling is likely a mixture of fuel, water and fire retardant.

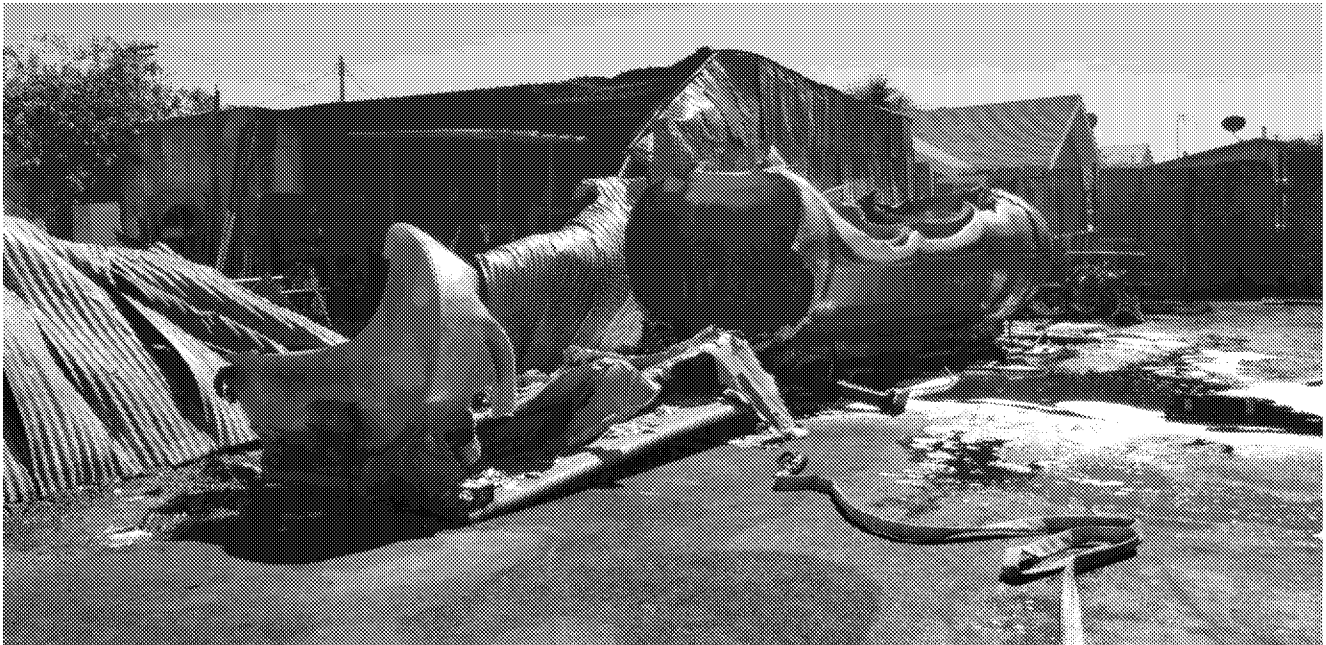
Figure #17.

View facing southeast at 210 W Slauson Ave, Parcel A, looking into Parcel B behind fire-damaged fencing. Entirety of fire-damaged "tanker" pictured. Ground pooling is likely a mixture of fuel, water and fire retardant.

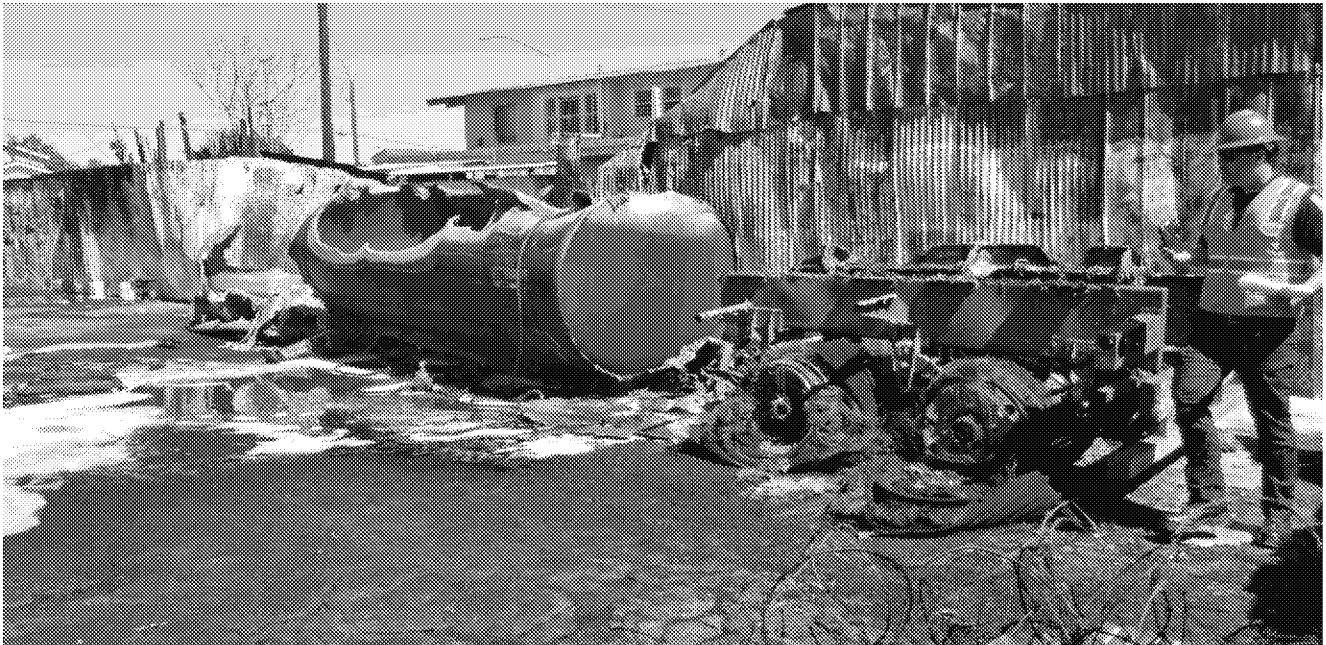
Figure #18.

View facing northeast at 210 W Slauson Ave, Parcel A, with fire-damaged “tanker” and fire-damaged wheels-and-axles component. Ground pooling is likely a mixture of fuel, water and fire retardant.

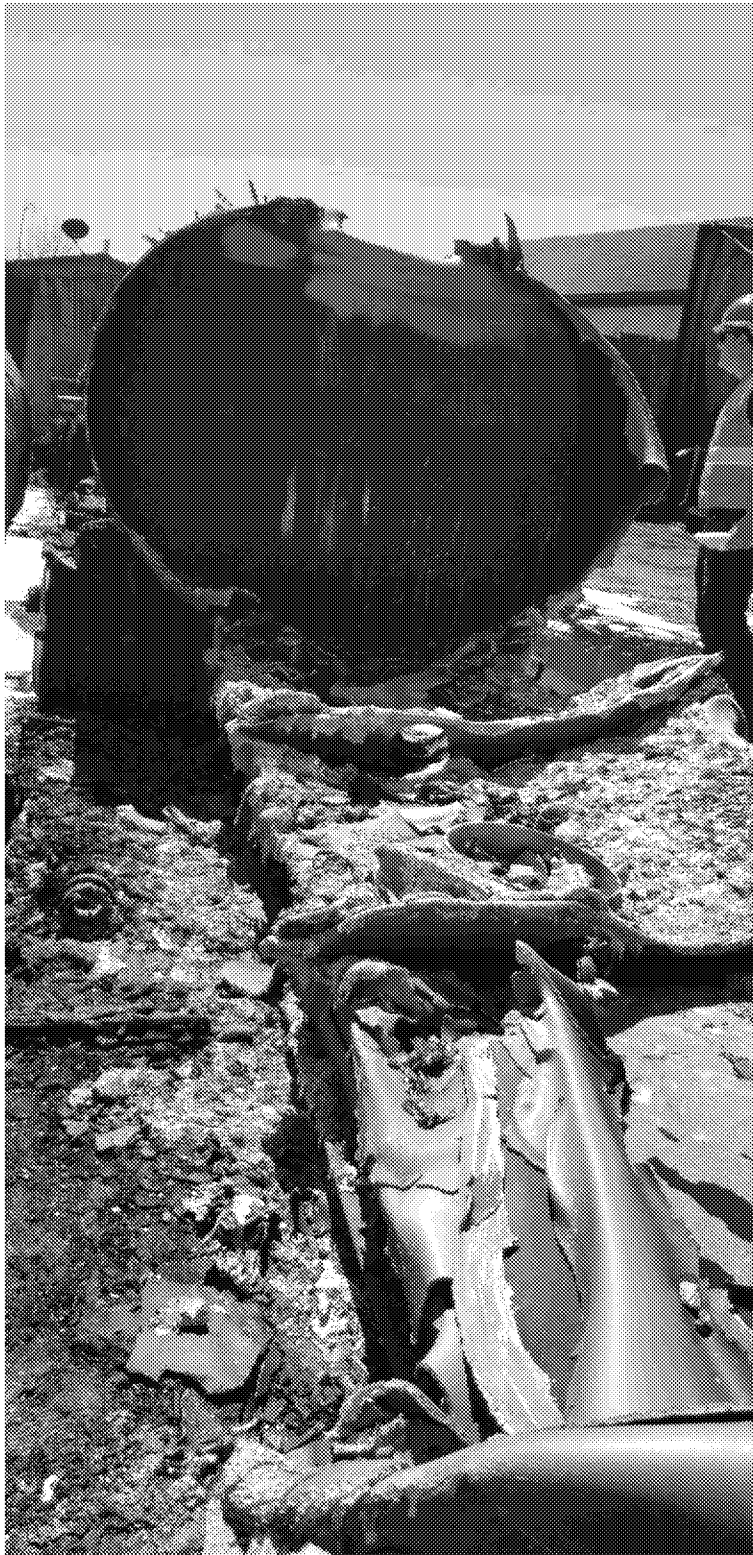
Figure #19.

View facing south at 210 W Slauson Ave, Parcel A. Front component of heavily fire-damaged "tanker" pictured.

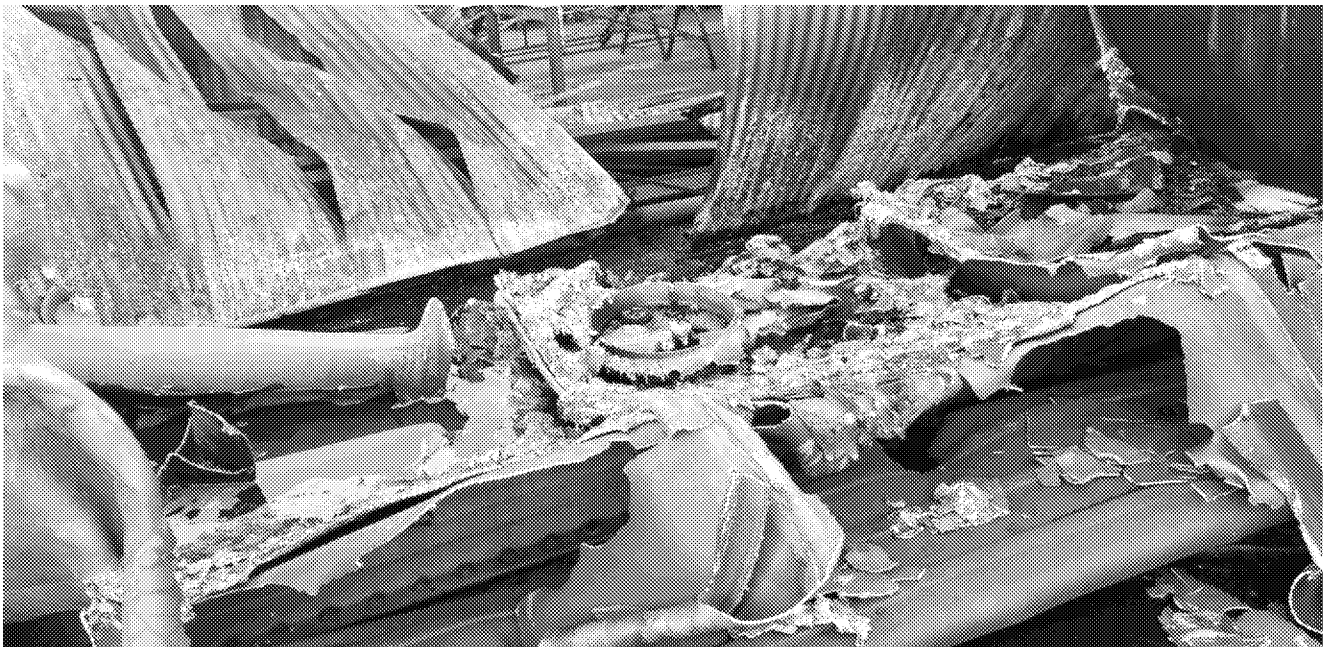
Figure #20.

View facing southeast at 210 W Slauson Ave, Parcel A. Front component of heavily fire-damaged “tanker” with likely a mixture of fuel, water and fire retardant inside. Fire-damaged fencing pictured in background.

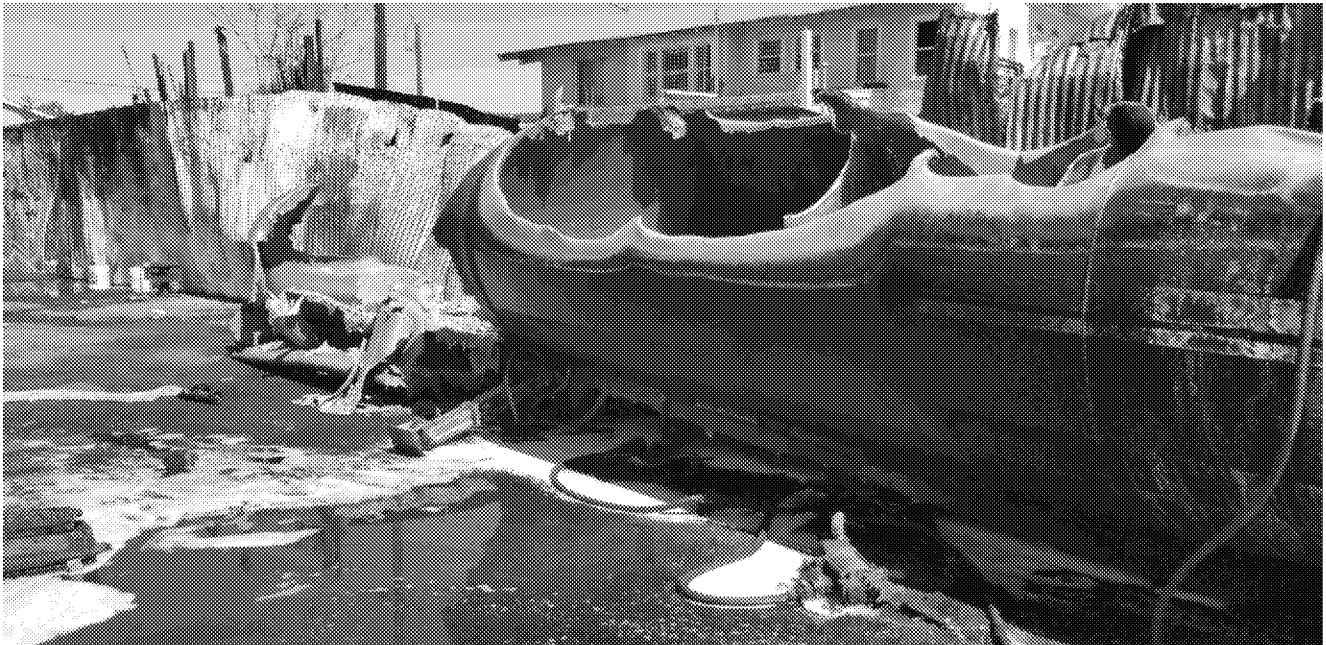
Figure #21.

View facing northeast at 210 W Slauson Ave, Parcel A. Side view of fire-damaged “tanker.” Ground pooling is likely a mixture of fuel, water and fire retardant. Fire-damaged fencing pictured in background.

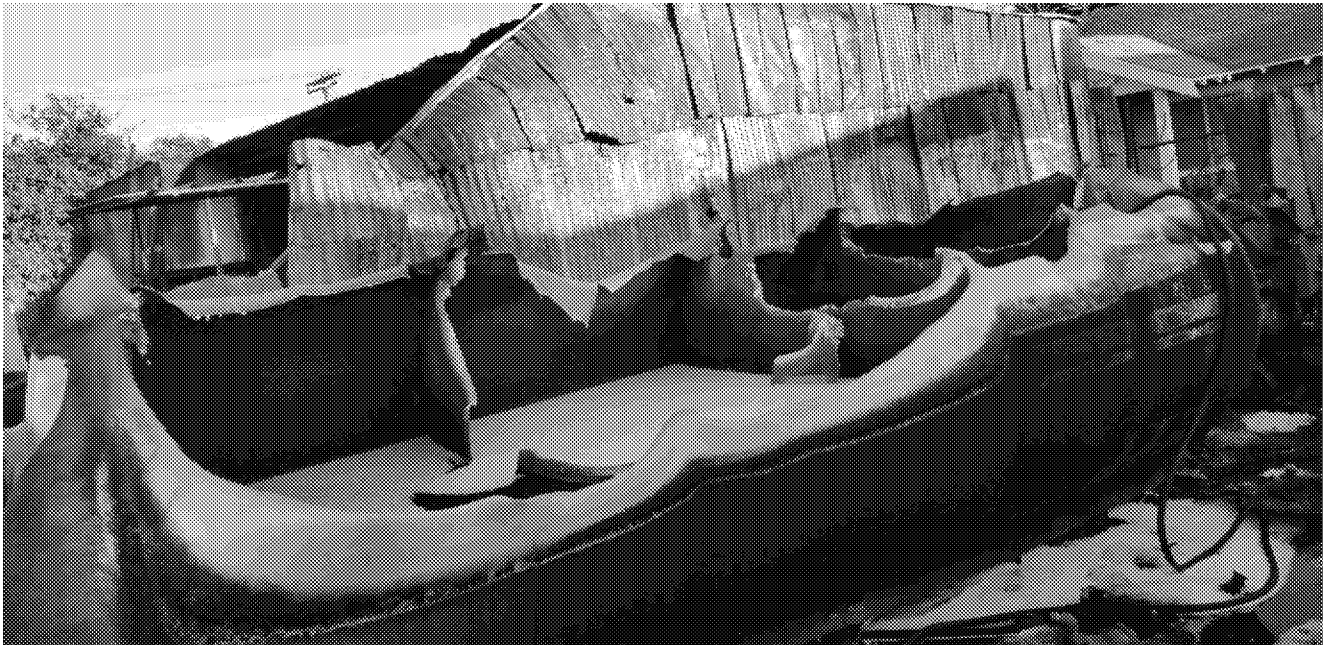
Figure #22.

View facing southeast at 210 W Slauson Ave, Parcel A. Side view of fire-damaged “tanker” with fuel and fire retardant inside.

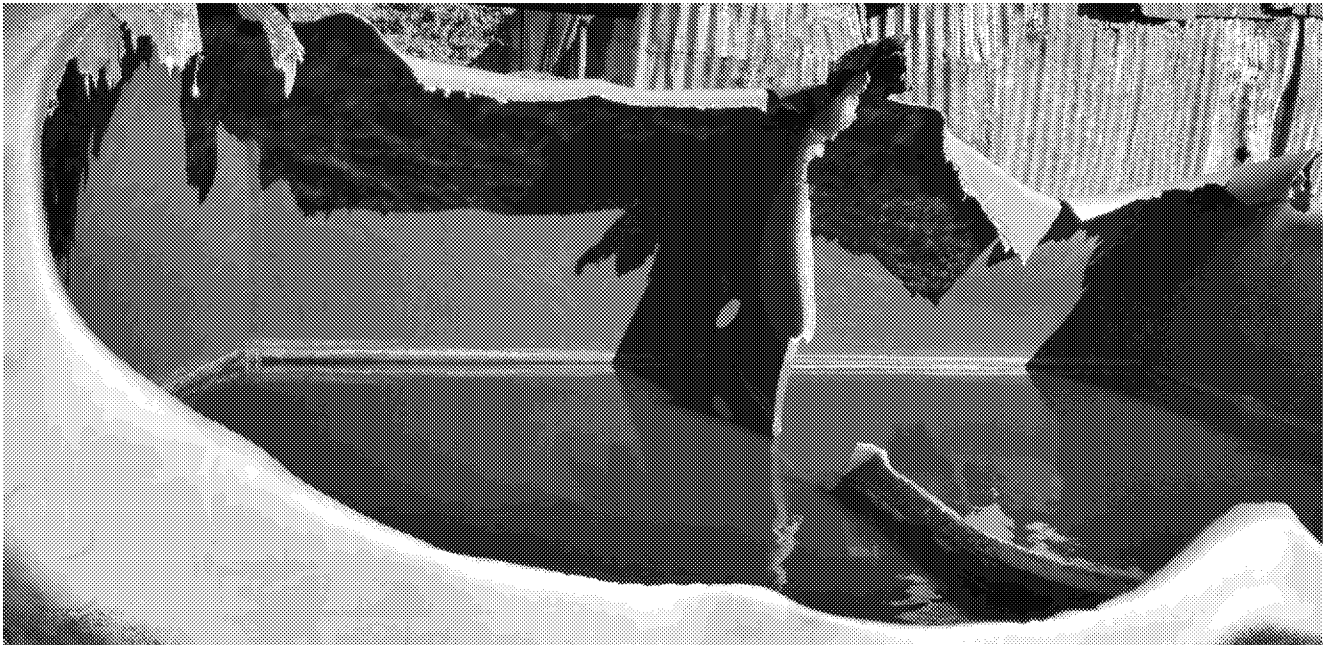
Figure #23.

View facing east at 210 W Slauson Ave, Parcel A. Close-up view inside of fire-damaged “tanker.”

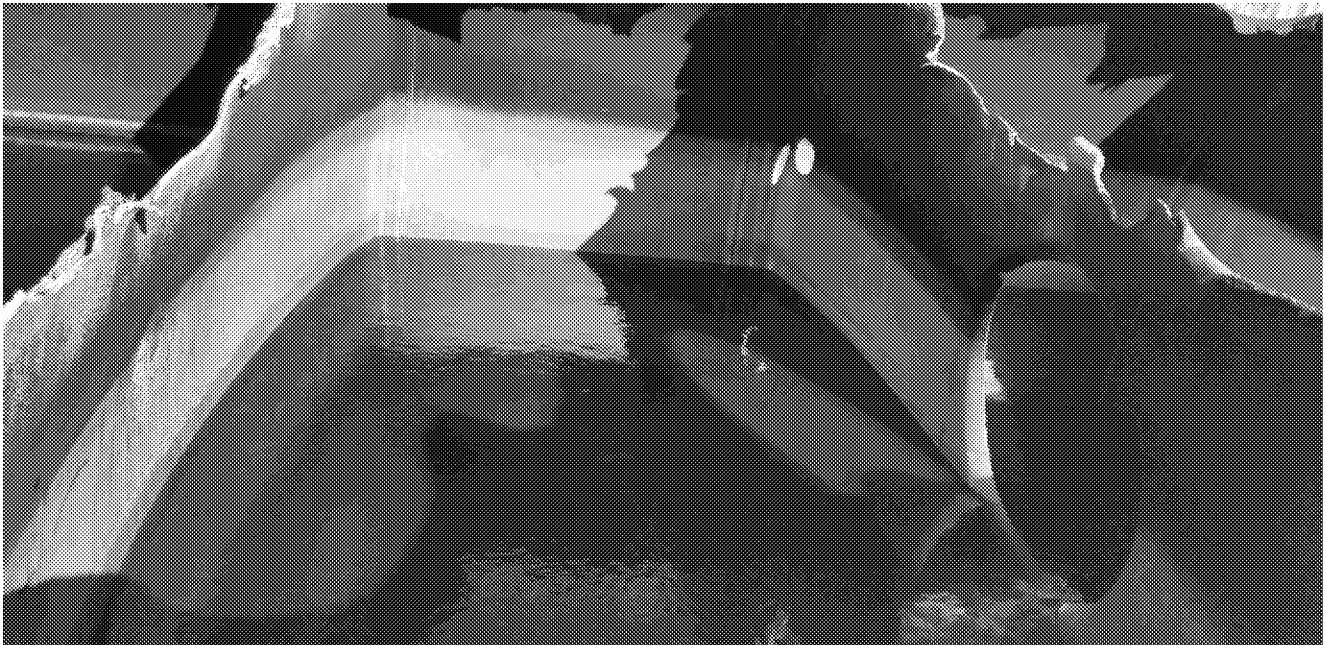
Figure #24.

Downward view inside of fire-damaged “tanker” on 210 W Slauson Ave, Parcel A.

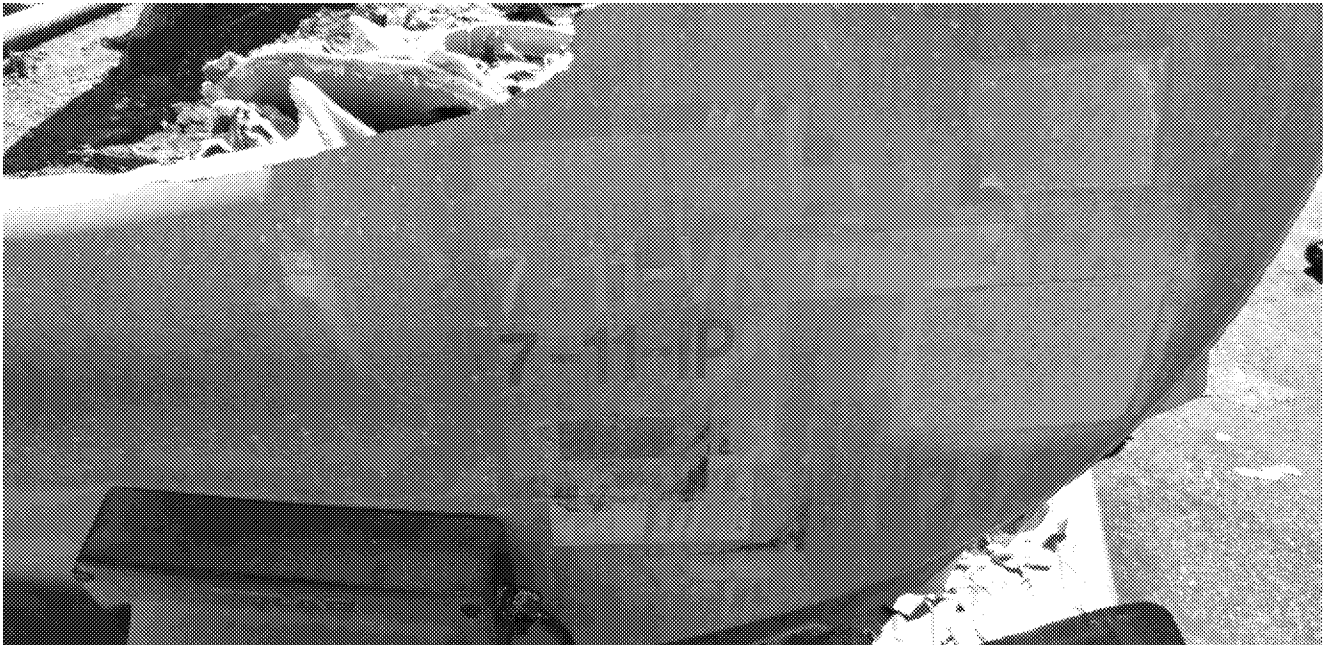
Figure #25.

View facing east at 210 W Slauson Ave, Parcel A. Side markings on the rear end of fire-damaged "tanker."
